Manhole Inspection Summary

Manhole # S43A2_035MH

Location Address: **3717 Saint Margaret St**

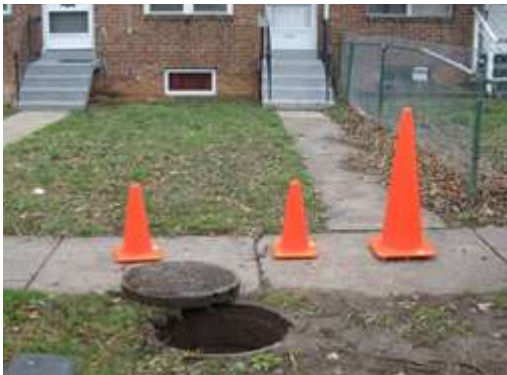
Location View

St. Margaret

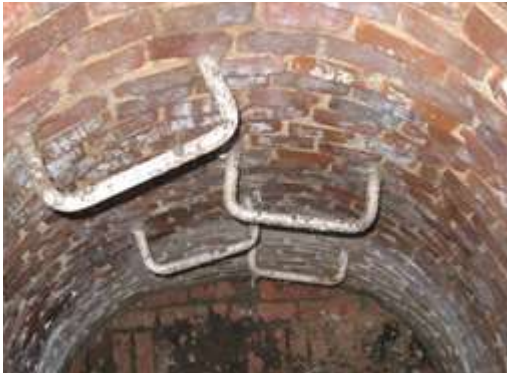
Steps

Count: **4** Missing: **0** ☐ Corroded

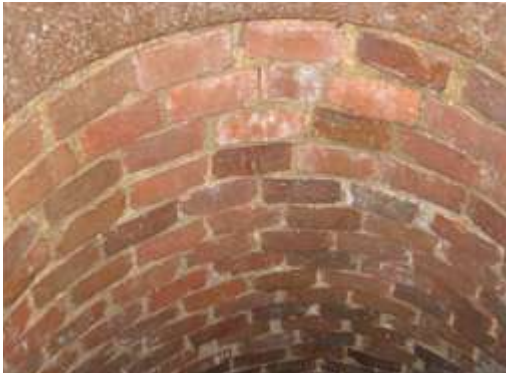
Defect 2

Infiltration: ☐ None ☐ Joint ☐ Cracks ☒ Mortar ☐ Roots ☒ Wall

Mortar

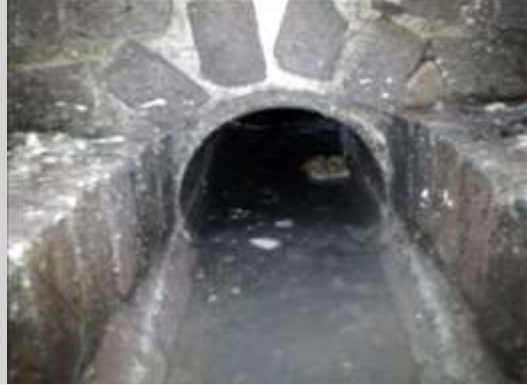
12 O'Clock Outflow

8 in. Circular Gravity Sewer
Pipe Out @ 12 O'Clock

Pipe Height: **9.6** (in.) Rod and Bar (Angled)
Pipe Material: **Clay** ☐ Pipe Lined
Invert Depth: **8.65** (ft.) Flow Characteristics: **Slow**
Deposits: ☒ None ☐ Mud ☐ Sludge ☐ Debris ☐ Grease
Silt Depth: (in.) Deposits Extent:
Infiltration: **None** Pipe Seal Cond: **Sound**

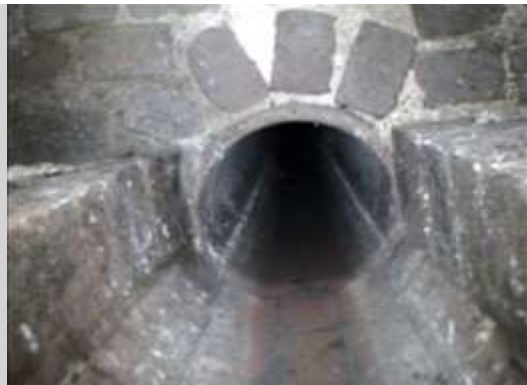
6 O'Clock Inflow

8 in. Circular Gravity Sewer
Pipe In @ 6 O'Clock

Pipe Height: **9.6** (in.) Rod and Bar (Angled)
Pipe Material: **Clay** ☐ Pipe Lined
Invert Depth: **8.48** (ft.) Flow Characteristics: **Slow**
Deposits: ☒ None ☐ Mud ☐ Sludge ☐ Debris ☐ Grease
Silt Depth: (in.) Deposits Extent:
Infiltration: **None** Pipe Seal Cond: **Sound**
